FACILITY COMPLIANCE INSPECTION REPORT

Division of Waste Management Solid Waste Section

Date of Site Inspection: 10/11/2011

Haywood County Municipal Solid Waste Landfill
 State Road 1338, White Oak Community
 Waynesville, N. C. 28786

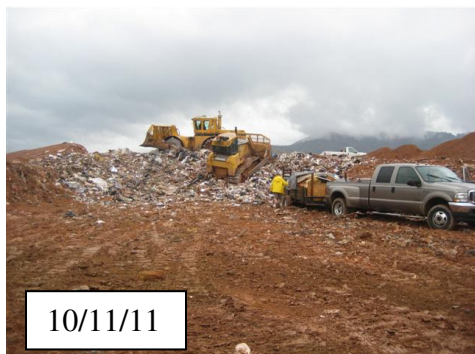
3. Roads were functional and in good condition and windblown fencing was in place. Note that windblown must be collected and returned to the working face daily. The operators were managing a small working face, compaction was ongoing, traffic flow was controlled with barriers and signs, and soil cover appeared adequate (ADC tarps were in use with soil cover utilized on a weekly basis in accordance with the facility Permit and Operations Plan). Note that continuous maintenance of the soil cover is recommended in order to control disease vectors, fires, odors, blowing litter, and scavenging. The scales had been recently removed/cleaned out as part of general semi-annual maintenance activities (per M. Shumpert).

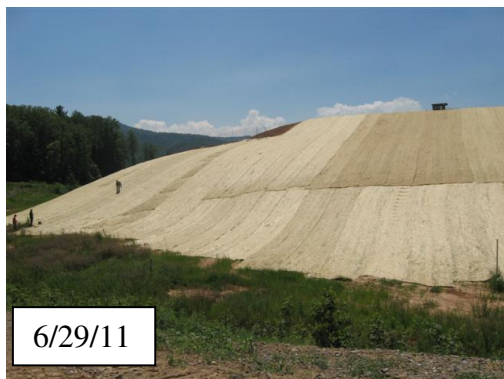
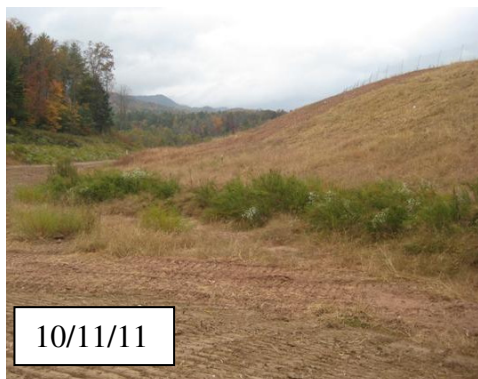
4. The repair work underway during the previous site inspection (seeding and matting) had substantially improved the soil erosion issues on the east side of the Phase 2 operations.

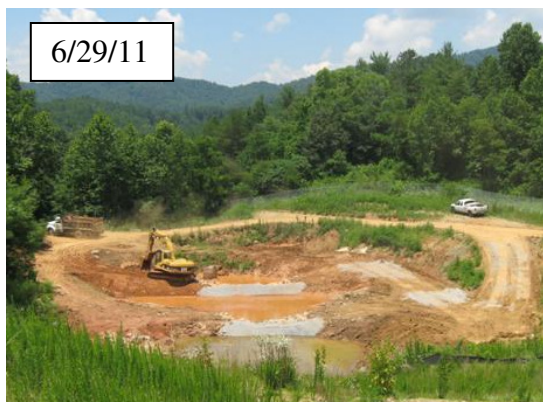
5. The facility was continuing to work on erosion control/sediment issues noted during the previous inspection including, but not limited to, the repair and maintenance of sediment basins (leachate lagoon region - sediment basin location shown below).

At lagoon, looking northward.

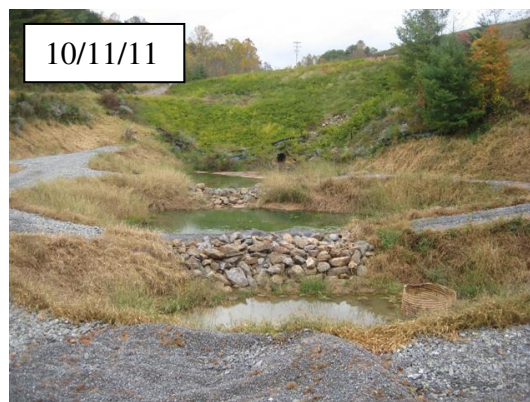
At sed basin, looking toward the lagoon.
